SILICONES TO THE RESCUE

A means to quickly seal charged air coolers was needed to get the trucking industry back on the road.

By David M. Brassard, Consulting Silicone Chemist, Silicone Solutions

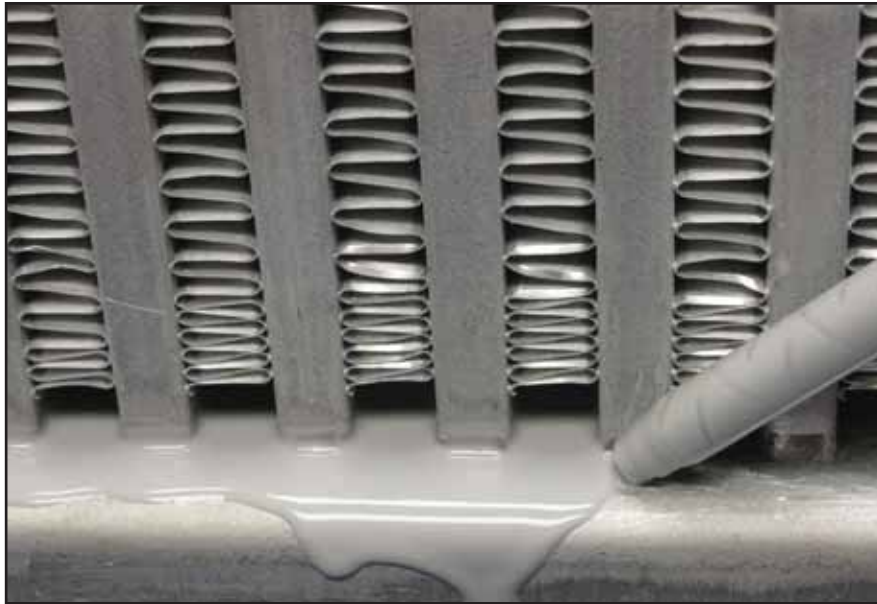
SS-1801 has the ability to seep into the CAG's several sub-layers and efficiently bond to, seal, and coat the base of the CAG around the fin mating areas.

The application technique for the CAG is quite simple. The CAG is held at a 45° incline, and a heavy stream of SS-1801 is run along the top of the base panel of the

unit and allowed to run into the fin mating areas. After a 15-min gel time for the coating, the CAG is rotated and inclined to expose the other side at a 45° angle.

A second coating is then placed on the uncoated side of the base and allowed to run into the fin and base plate interface and cure. This fully coats the base pan and fin interface. The same technique is used for in-field repair and OEM production.
